## **Pipeline Group Factual Report**

#### **Stork Draft HA-DM 12" Joints Exam plus Inspection Data**

Report No. 0270-07-17309

Testing and Examination of Pipe from  
Dixie Pipeline Company's  
12-inch Hattiesburg, MS to Demopolis, AL Pipeline

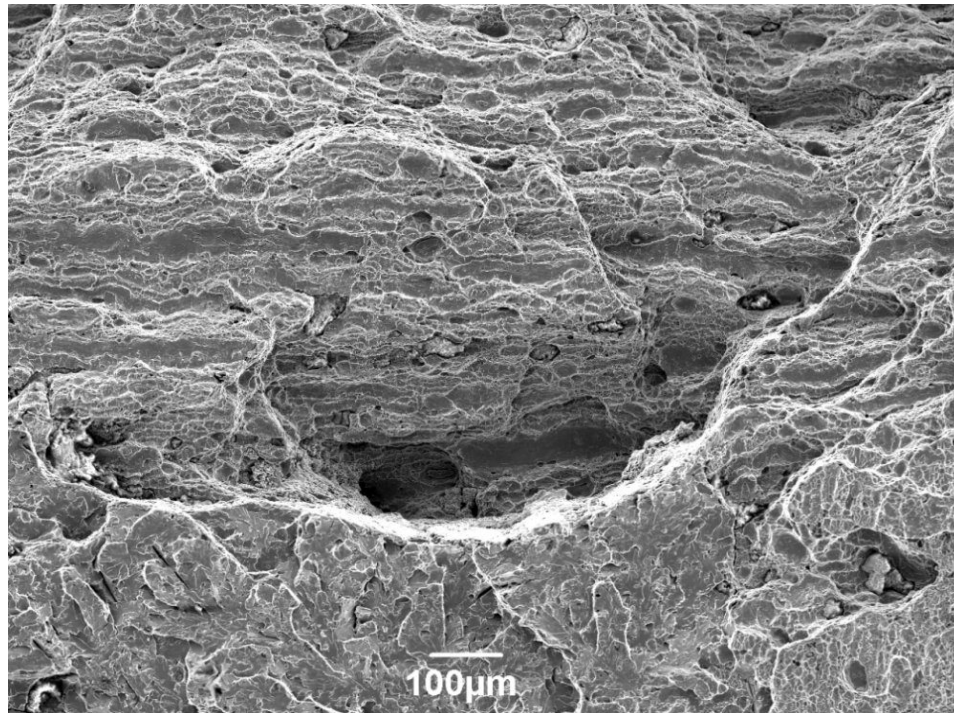
Figure 115 shows a large area of woody fracture, and Figure 116 shows a typical location at higher magnification.

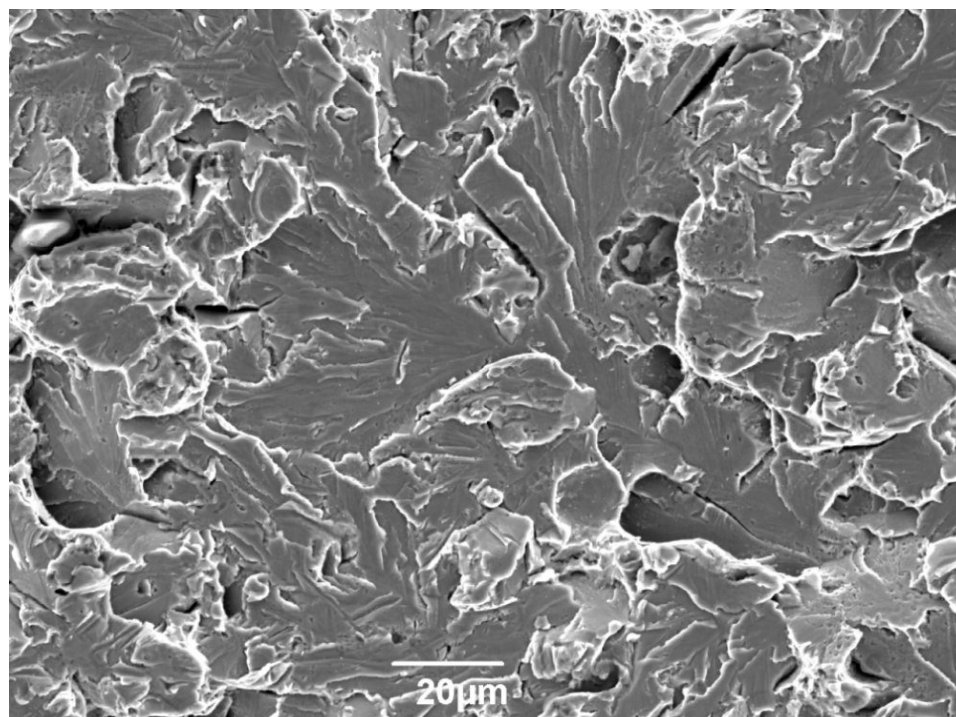
Transition from woody fracture, at top, to cleavage fracture at bottom.

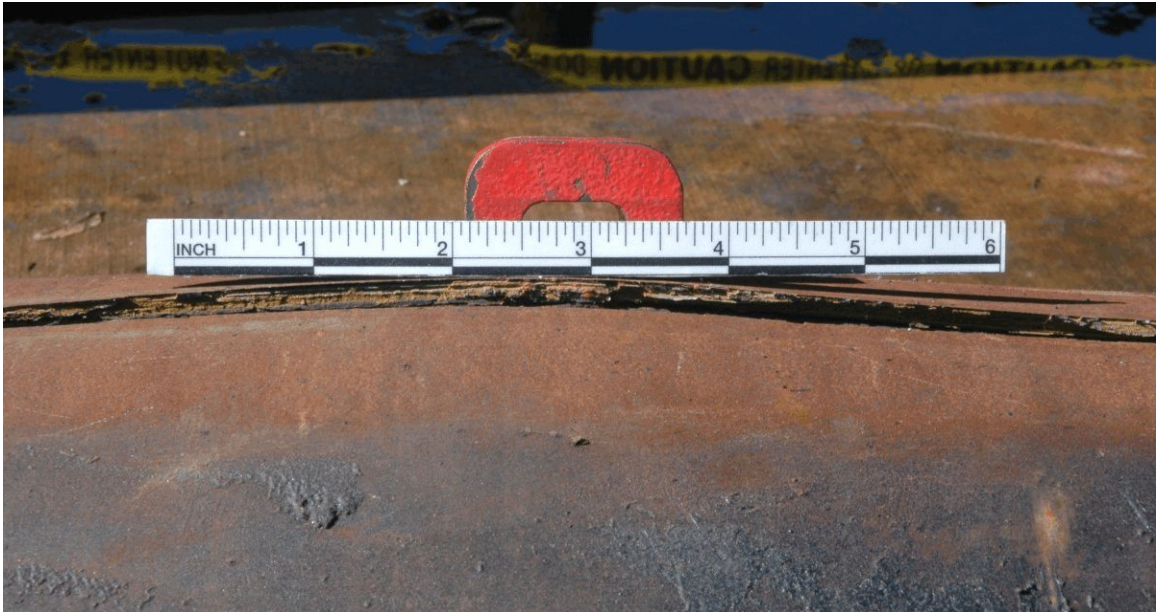
Joint No. 10737

Photograph of the rupture in the fatigue test section from Joint No. 10737.

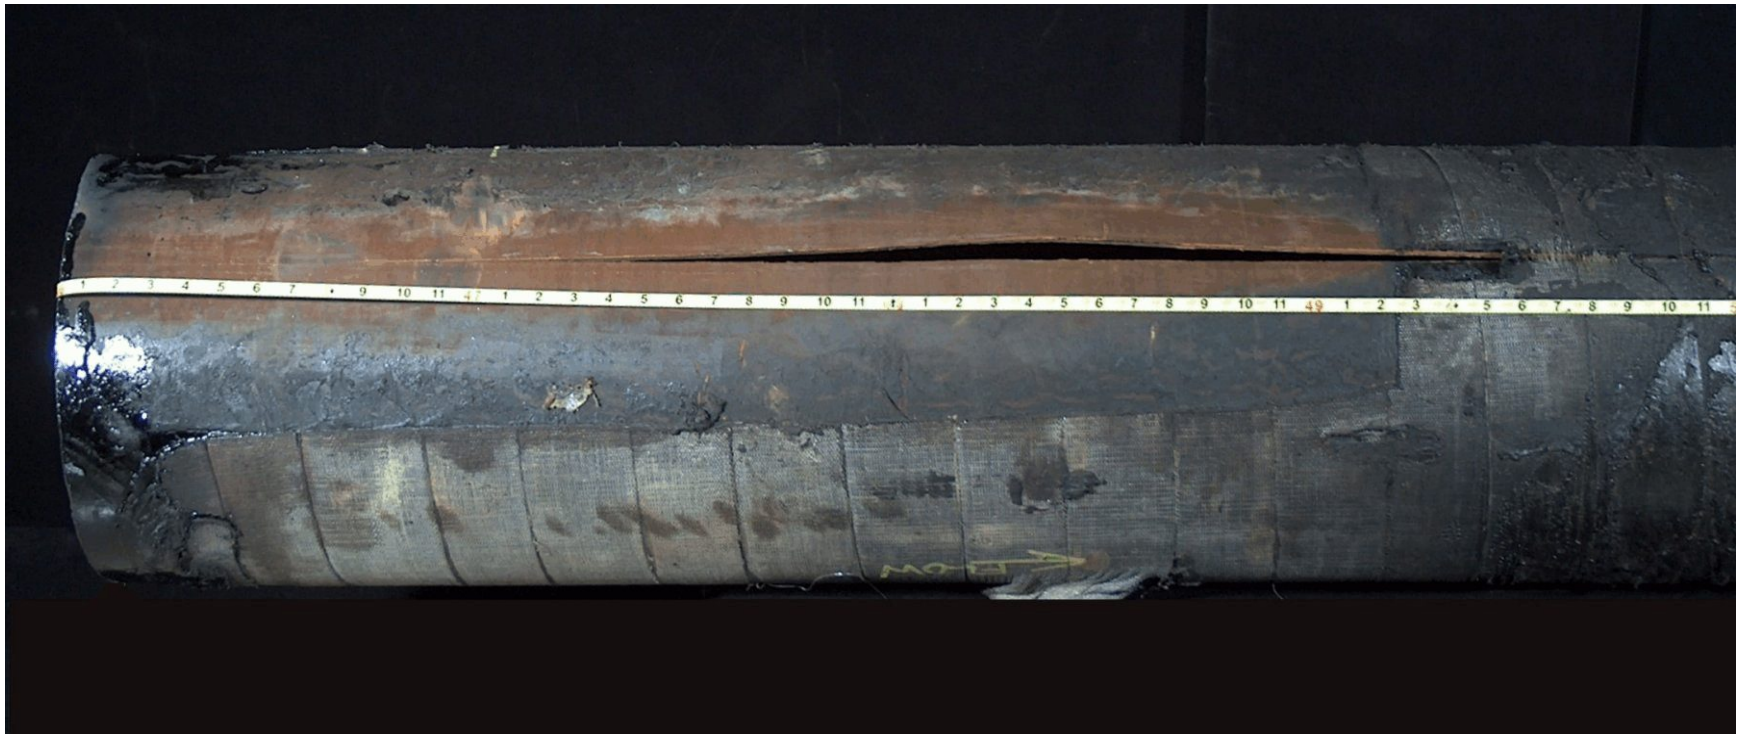
Joint No. 10737

Closer views of the fracture at the middle of the rupture.

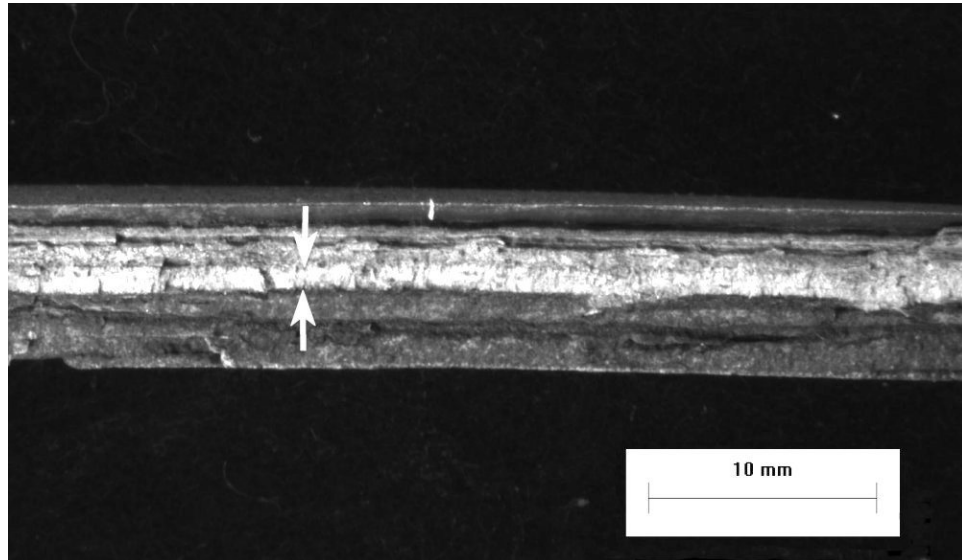
Joint No. 10737

Photograph of the hook crack near the downstream end of the rupture, arrow.

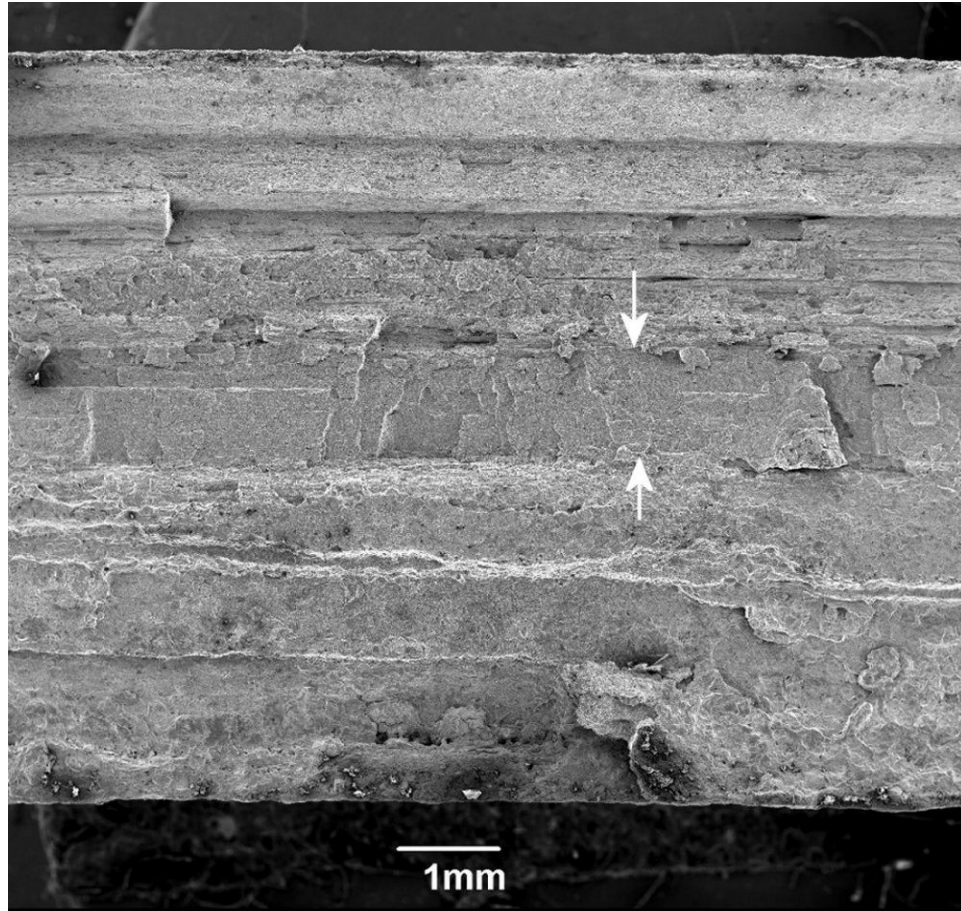
7. Visual and fractographic examinations of the fracture surface from the fatigue test showed a small area with fracture characteristics that were likely due to fatigue crack propagation.

Close-up views of part of the fracture with suspected fatigue markings, between arrows.

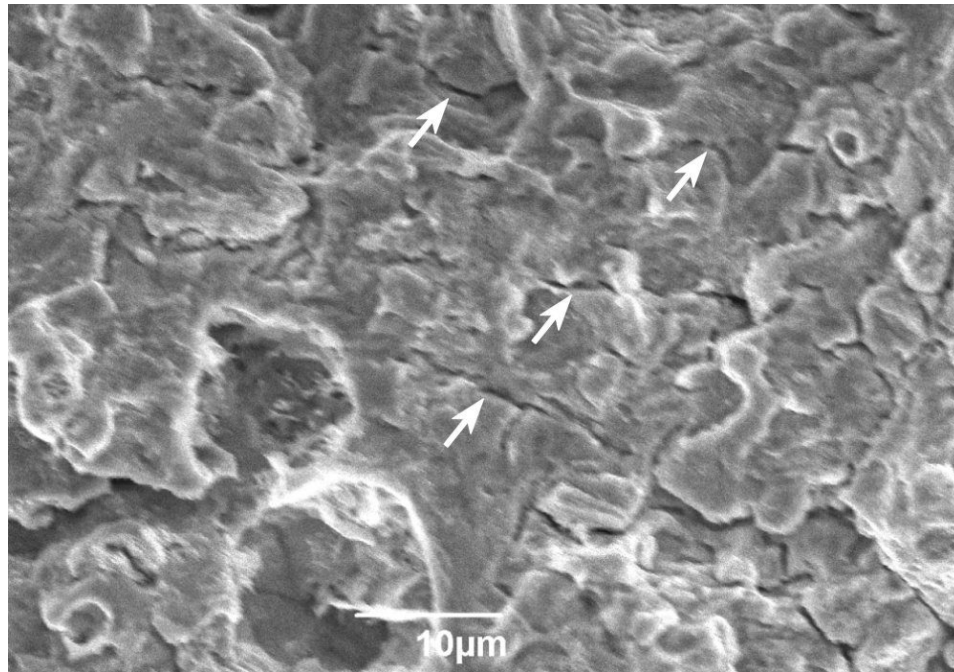
Electron micrograph of the fracture toward the outside surface. The letters indicate features shown in subsequent figures.
